HAWAIIAN HOME LANDS

Papakōlea-Kalāwahine Community Meeting

January 16, 2024

Individual Property Assessments Completed

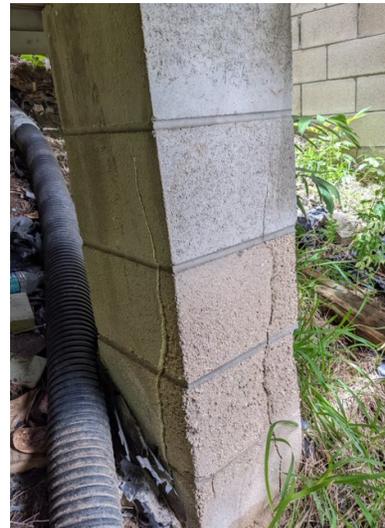
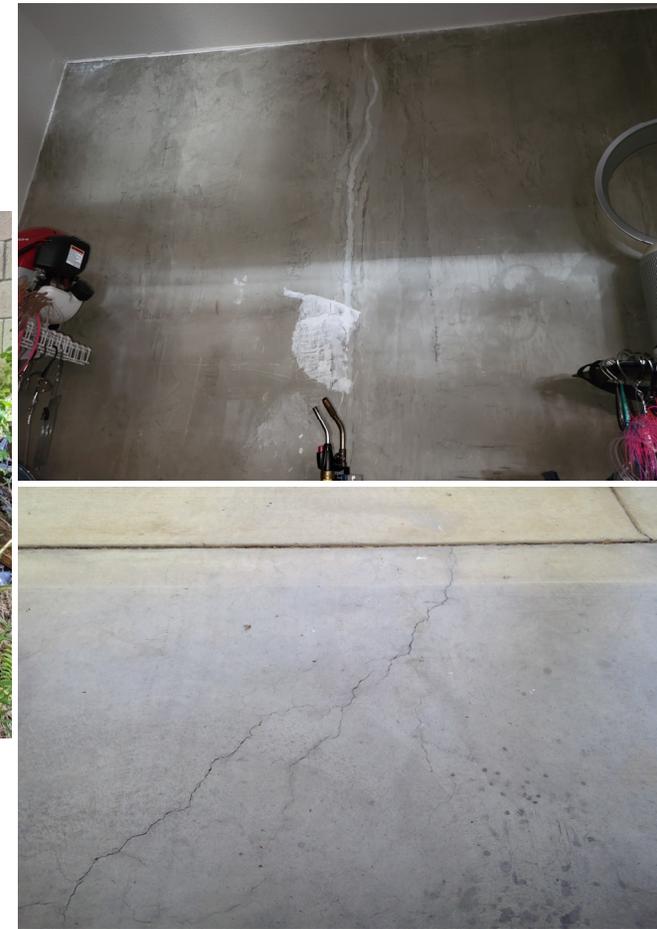
- No visible signs of structural distress, no immediate life safety concerns.
- Minor cracking in concrete retaining walls and slabs-on-grade. Cracks of interest were identified for further monitoring (cracks wider than approximately 1/16").
- CMU pier spalling and cracking, weathered shell.
- Drywall cracks, gaps and cracks in siding and molding, stuck window and doors may be indication of building movement.
- Review of original structural drawings indicates standard residential framing, detailing, and foundations.
